FINAL REPORT

**TECHNICAL FEASIBILITY DEMONSTRATION MODEL
OF ORBITING EXPERIMENT FOR STUDY
OF EXTENDED WEIGHTLESSNESS**

**Biotechnology
LOCKHEED MISSILES & SPACE COMPANY
Sunnyvale, California**

**NATIONAL AERONAUTICS AND SPACE ADMINISTRATION
Langley Research Center**

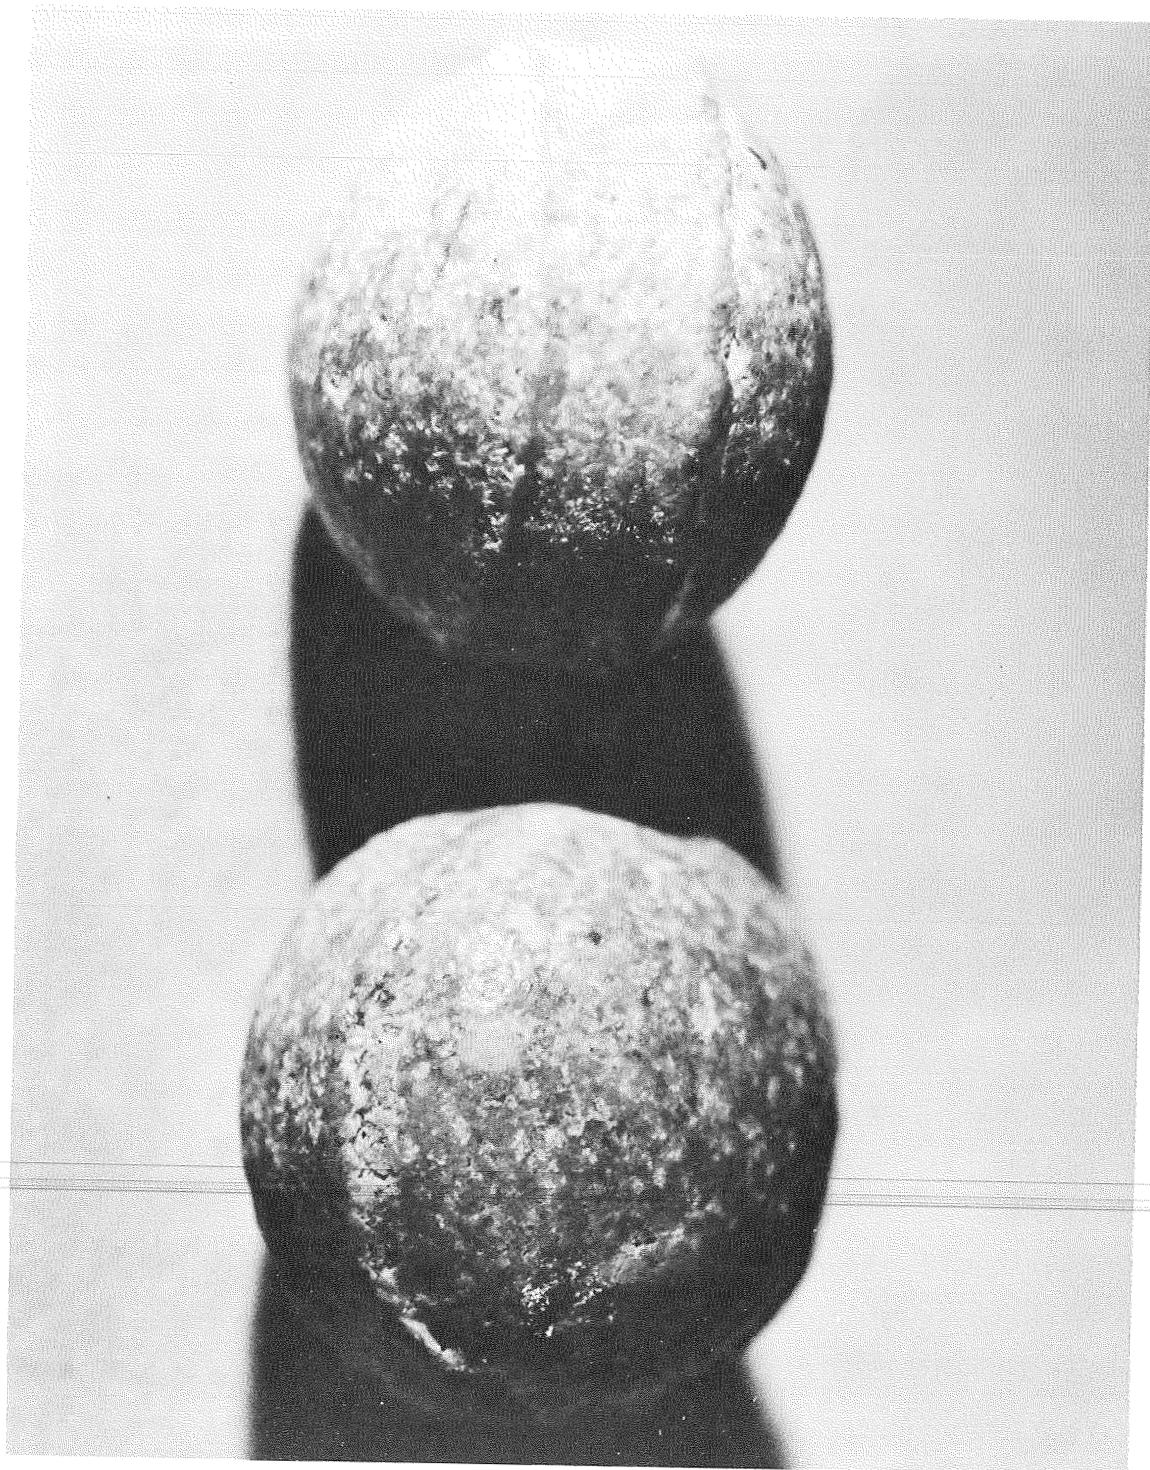
Figure 23 Uncoated Tablets

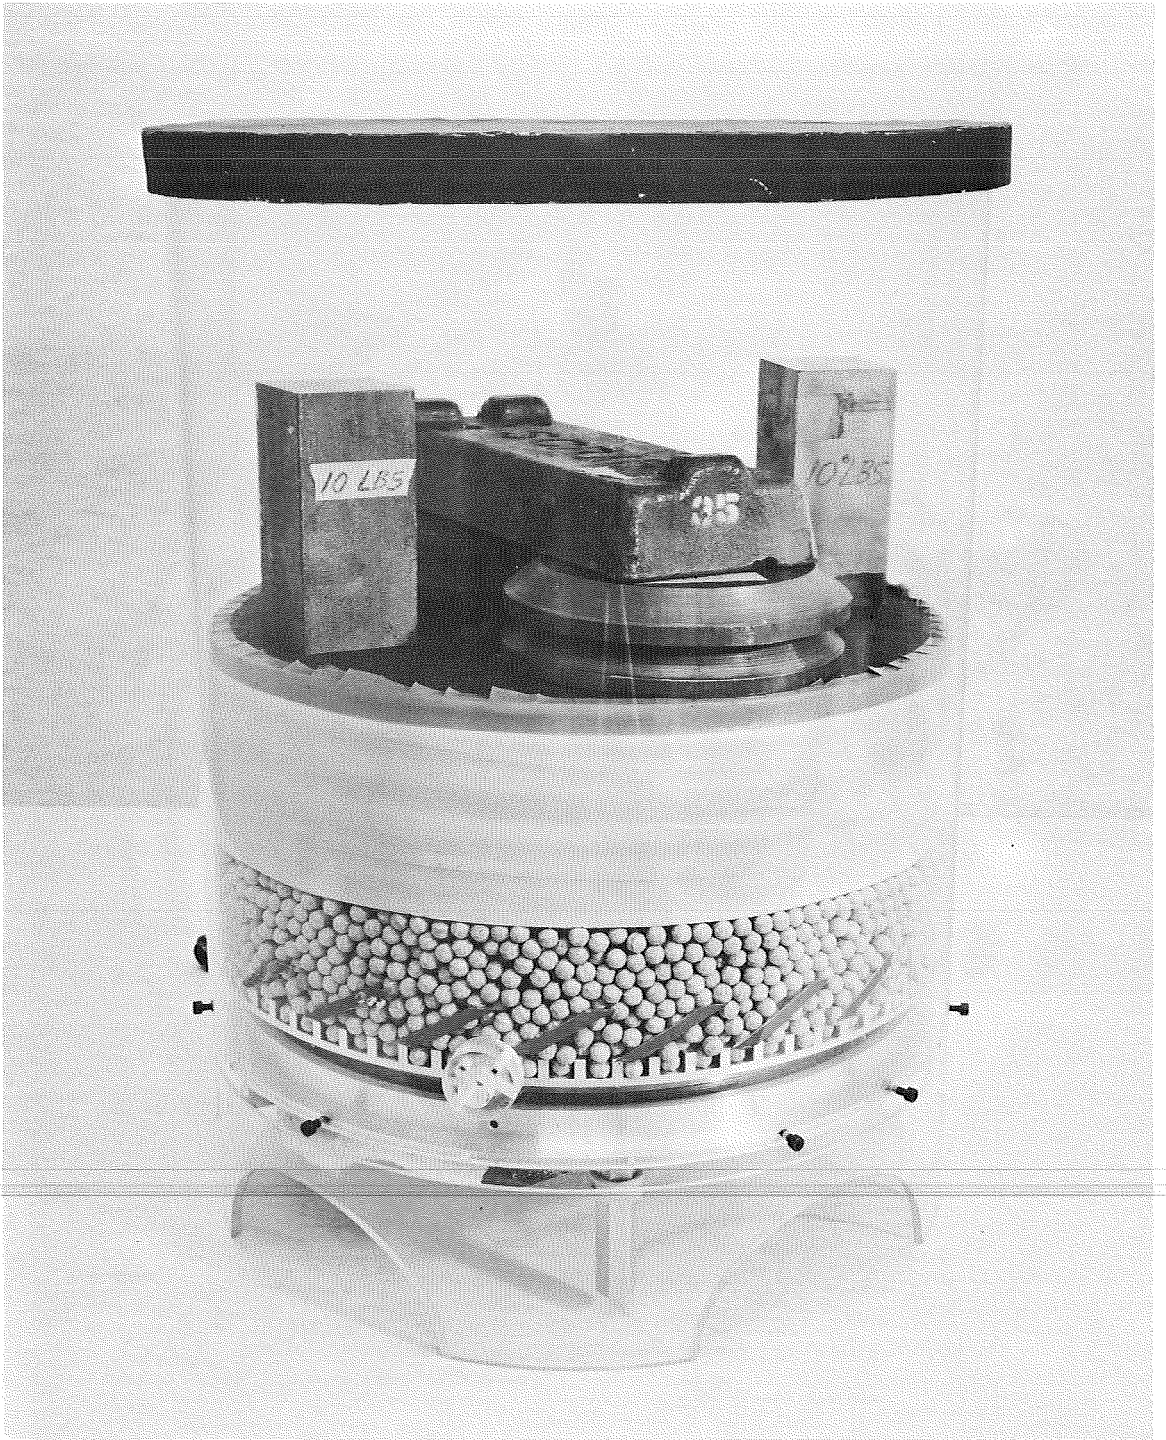
Figure 42 Feeder Pressure Plate Installed and Loaded

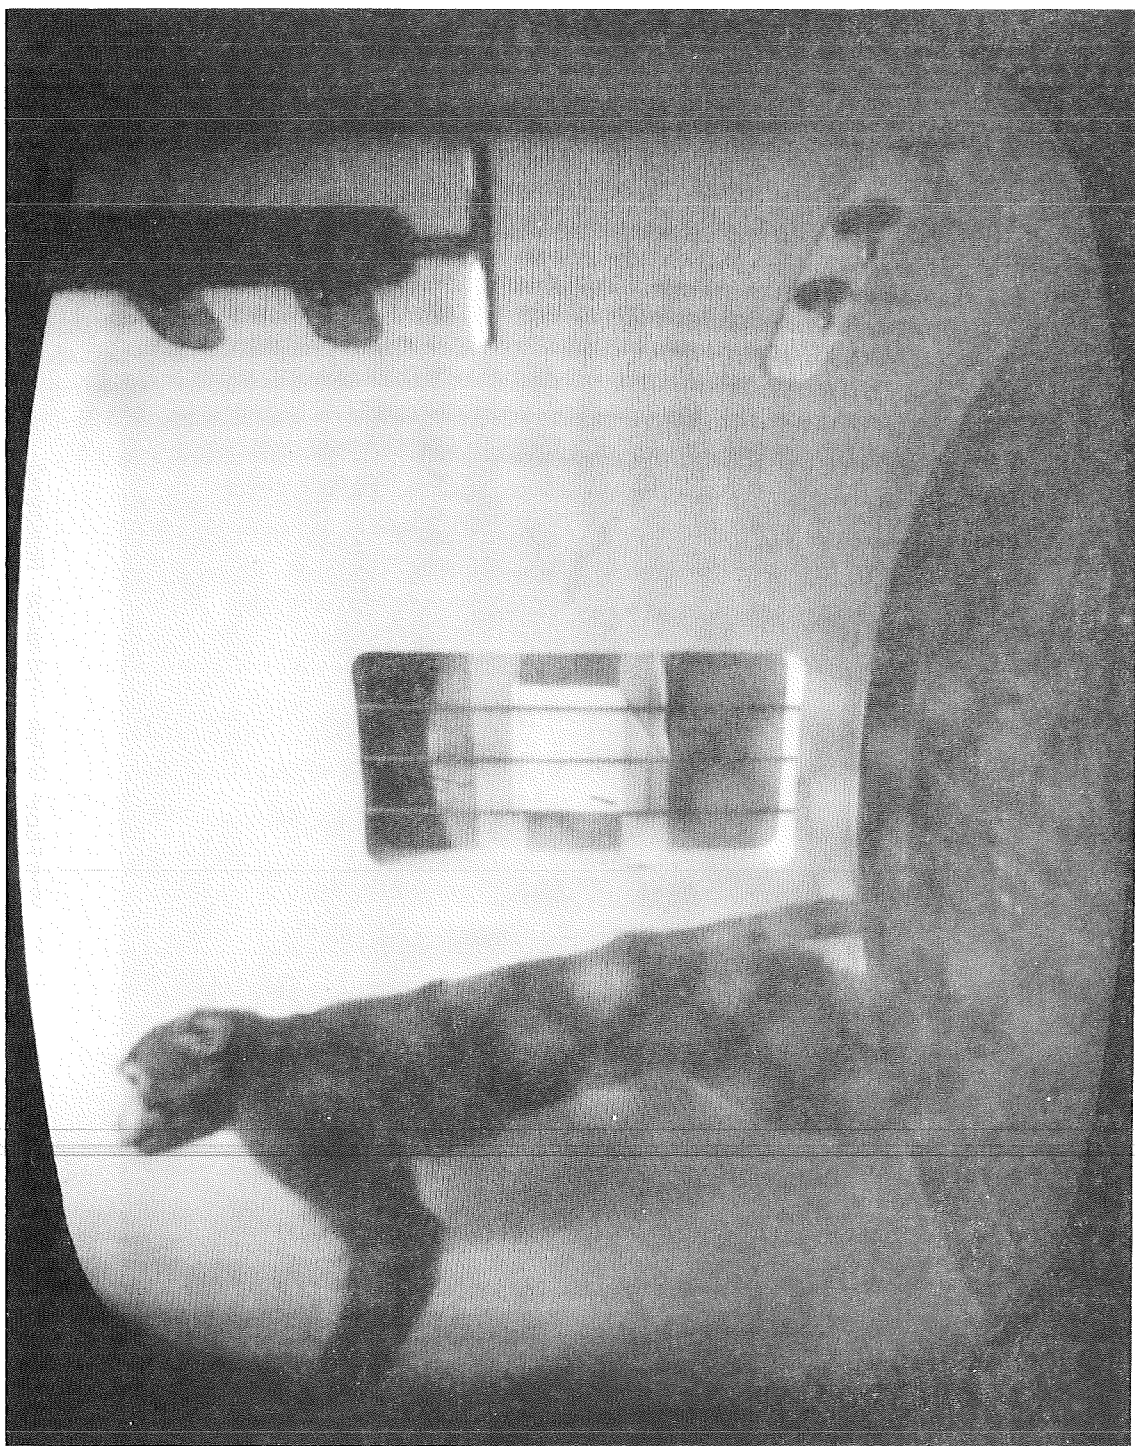
Figure 59 Photo of TV Monitor Showing Primate (Side Camera)
